Callisto Non-Conformance report

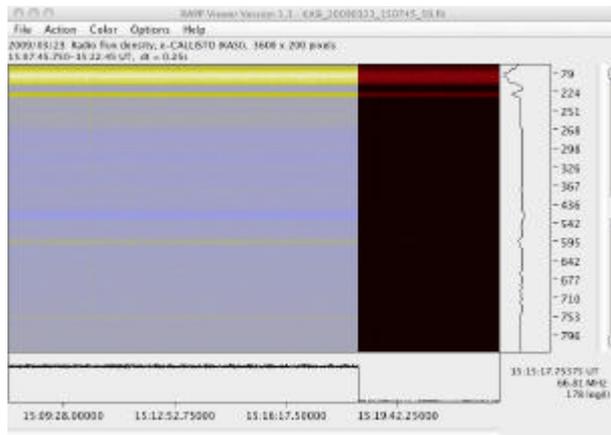
*We have experienced a series of strange behaviour with it:
 -First if we let it on for a while it might, in a sense, "lose its sensitivity" as illustrated in figure 1.. This happened several times already. We thought it was linked to our PC since we cannot reproduce this behaviour on another PC.*

Figure 1: sudden decrease in intensity, picture Ch. Marqué, ROB

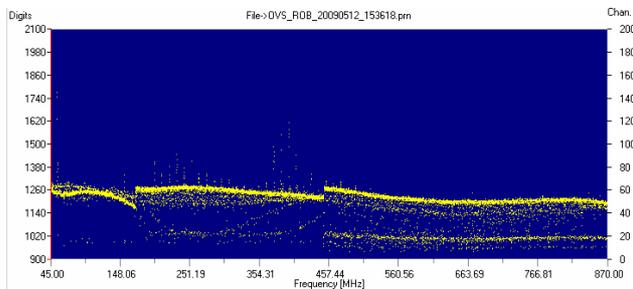
The instrument was then sent to our lab and, by producing a spectral overview we could confirm a strange behavior. After taking out the electronic board we measured the signal level of the I2C-bus interface. According to specification of Philips the level should be between 3.5 V and 5.0V. In fact the level was about 3.2 V for I2C-data and also for I2C-clock. From rfi point of view the level should be as low as possible to not produce

interference from processor clock via I2C into the tuner. But in this case the I2C level shifter was wrongly designed (R1 and R2 560 ohms, R3 and R4 1 k). In future upgrades or during revisions the resistors R3 and R4 must be changed to 1.5 k to guarantee minimum bus level for Philips tuner.

Figure 2: spectral overview showing decrease in level.
